NPIC/R-704/64 August 1964

PHOTOGRAPHIC INTERPRETATION REPORT

NORTHWEST PROBABLE ANTIMISSILE-MISSILE LAUNCH COMPLEX LENINGRAD, USSR MAY AND JUNE 1964

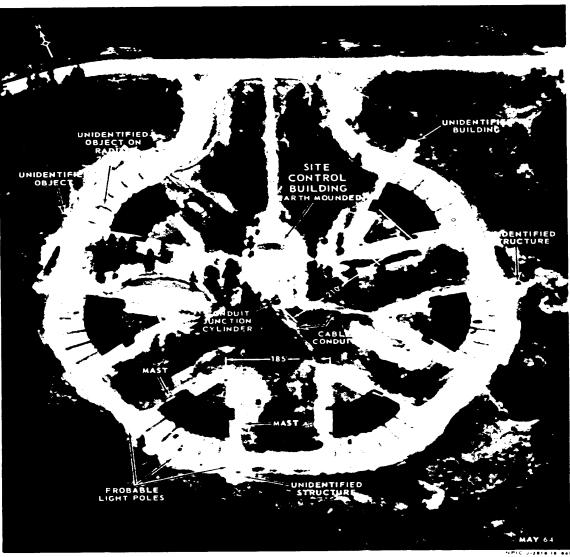
FIGURE 6. LAUNCH SITE B.

An unidentified object

is positioned on one of the outer radials at Launch Position B6 (Figure 6).

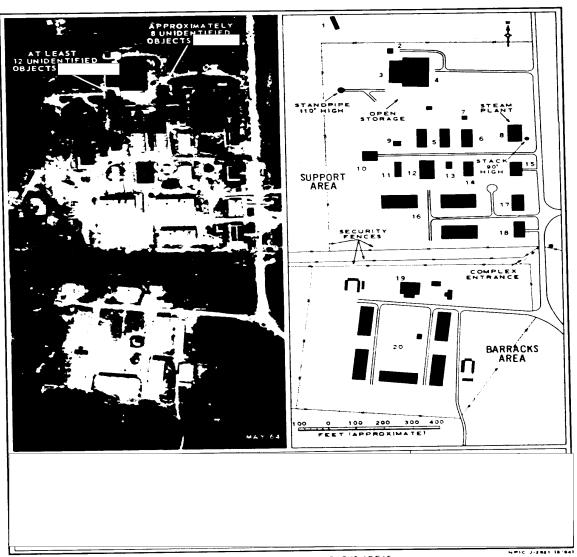
FIGURE 11. SUPPORT AND BARRACKS AREAS - 14 -

The May photography revealed two groups of unidentified objects in open storage adjacent to the largest building in the Complex Support Area (Figure 11). These objects were dark in tone and their edges were obscure. One group of at least 12 objects

each and the other group contained approximately eight objects each of which

The group of approximately eight and several from the group of at least 12 had been removed

when the area was observed on the June coverage.

A line drawing of the Support and Barracks Areas (Figure 11) is included to convey structure dimensions.
